# MINERAL MATERIALS SURVEY of the SEWARD and GLACIER RANGER DISTRICTS ROAD CORRIDOR, CHUGACH NATIONAL FOREST, ALASKA.

## Volume I: Summary and Site Descriptions

by Gary E. Sherman, Earle M. Williams, and Mark P. Meyer

Alaska State Office  
May 1997

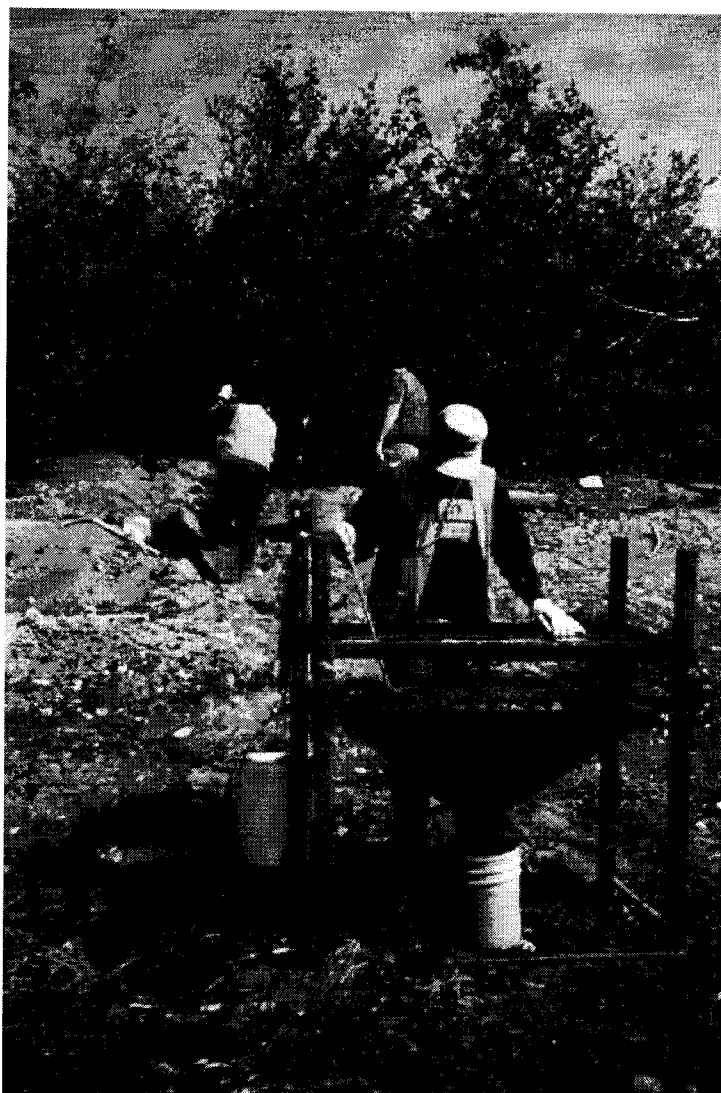
Figure 2. - Using the screening device to sample gravels on the West Juneau Creek Road.
